N.G. JACOBSON & ASSOCIATES, INC.

**RE: River Park Square Parking Garage
NGJ #2238.101**

RIVER PARK SQUARE PARKING GARAGE, SPOKANE, WASHINGTON
20 Year Life Cycle Cost Evaluation of Existing Parking Garage

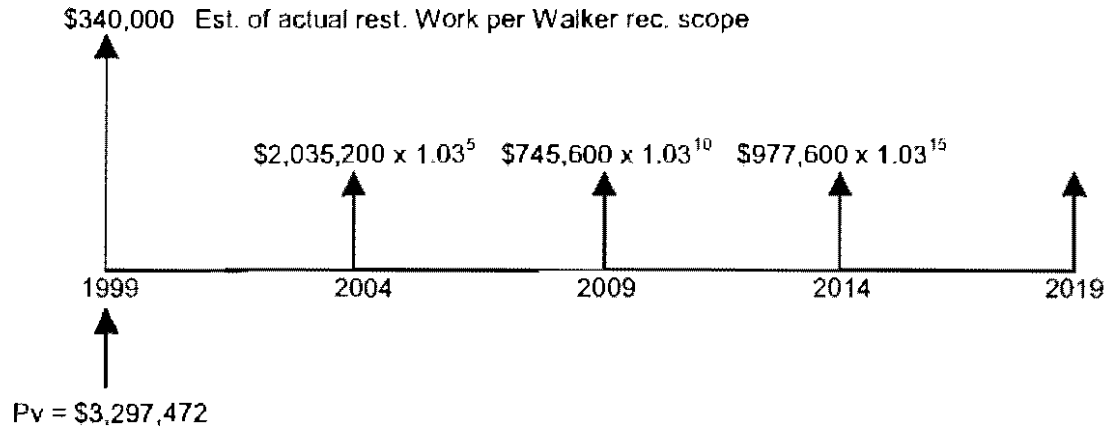
Estimated Life Cycle Costs are the Total Equivalent Cost at Present Values Based on the Following Assumptions:

Interest Rate: 6%/Year
 Inflation: 3%/Year
 Project Life: 20 Years

Repair/Restoration Costs:	5 YR	10 YR	15 YR
Concrete Slab Repair	\$300,000	\$90,000	\$110,000
Conc. Slab Soffit, Beam, Column Repair	\$175,000	\$100,000	\$60,000
Precast Spandrel Repair	\$95,000	\$32,000	\$40,000
New Traffic Membrane System	\$500,000	\$0	\$0
Recoat W.P. Membrane	\$23,000	\$155,000	\$313,000
Crack and Joint Sealant	\$106,000	\$35,000	\$25,000
Pavement Markings	\$13,000	\$4,000	\$13,000
Misc. Repair/Restoration			
Waterproofing	\$50,000	\$50,000	\$50,000
Expansion Joint Seal	\$10,000	\$0	\$0
Sub-Total	\$1,272,000	\$466,000	\$611,000
Mark-up Factor 0.6*	\$763,200	\$279,600	\$366,600
TOTAL ESTIMATE	\$2,035,200	\$745,600	\$977,600

* Markup factor includes: Contractor general conditions (including barriers, and traffic control), overhead and profit, contingencies, sales tax and soft costs for design and construction management.

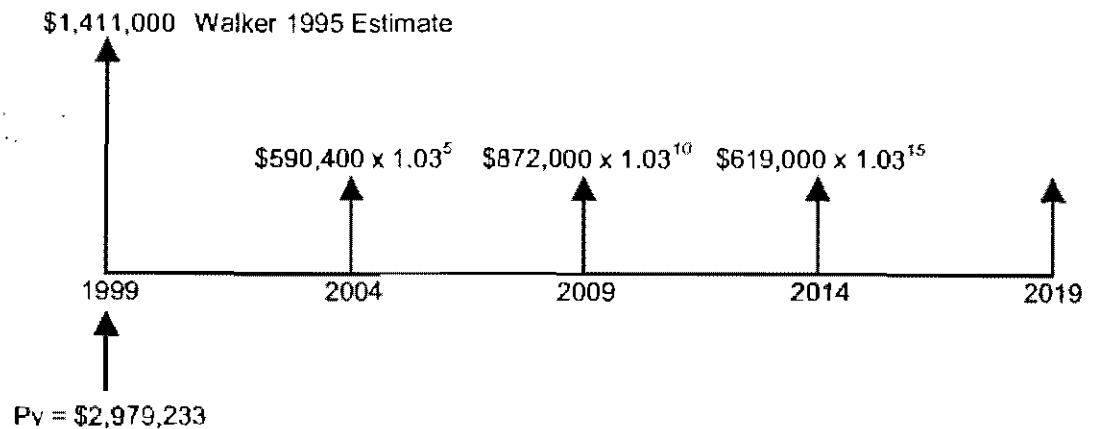
**RIVER PARK SQUARE PARKING GARAGE, SPOKANE, WASHINGTON
20 Year Life Cycle Cost Evaluation per Walker Parking Consultants
1996 Condition Assessment Report's Recommendations**

Estimated Life Cycle Costs are the Total Equivalent Cost at Present Values Based on the Following Assumptions:

Interest Rate: 6%/Year
 Inflation: 3%/Year
 Project Life: 20 Years

Repair/Restoration Costs:	5 YR	10 YR	15 YR
Concrete Slab Repair	\$36,000	\$60,000	\$90,000
Conc. Slab Soffit, Beam, Column Repair	\$100,000	\$60,000	\$60,000
Precast Spandrel Repair	\$18,000	\$24,000	\$32,000
Recoat W.P. Membrane	\$116,000	\$313,000	\$116,000
Crack and Joint Sealant	\$35,000	\$25,000	\$35,000
Pavement Markings	\$4,000	\$13,000	\$4,000
Misc. Repair/Restoration			
Waterproofing	\$50,000	\$50,000	\$50,000
Expansion Joint Seal	\$10,000	\$0	\$0
Sub-Total	\$369,000	\$545,000	\$387,000
Mark-up Factor 0.6*	\$221,400	\$327,000	\$232,200
TOTAL ESTIMATE	\$590,400	\$872,000	\$619,200

* Markup factor includes: Contractor general conditions (including barriers, and traffic control), overhead and profit, contingencies, sales tax and soft costs for design and construction management.

1. Financial Feasibility Analysis & Condition Assessment for the River Park Square Parking Garage - Final Report by Walker Parking Consultants/Engineers, Inc. (June 14, 1996)
